Tunnel erosion control on Coolangatta Mountain, Berry

The Project

This project treated two areas of active tunnel erosion (0.22ha in size) at the foothill of Coolangatta Mountain. The project was planned and completed by the Department of Lands, Nowra in 2007.

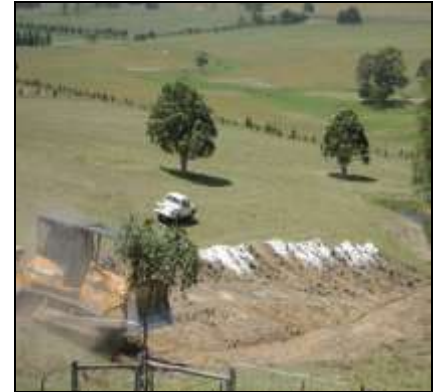
Department of Lands undertaking remedial works on gully 1, which feeds into the farms main dam for livestock.

The gully was ripped and backfilled with gypsum and soil. A diversion bank was constructed to protect the area, before it was sown with grass seed and fertiliser. The site was then fenced (50m x 20m wide) and planted with local tubestock.

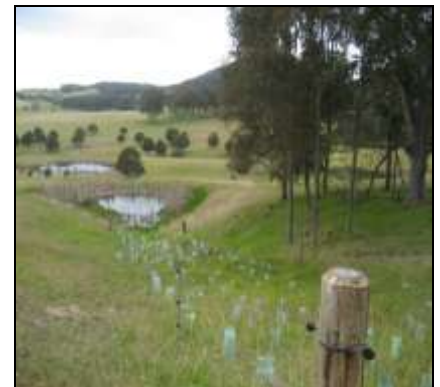
Gully 1. Revegetation of the gully has been difficult due to secondary weeds emerging.

Excellent 2007 spring and summer rain assisted with revegetation efforts. However, good rain and soil disturbance resulted in significant weed growth. The landholders have cut back the weeds and seeded the site again with 2008 autumn rains to help out compete new emerging weeds.

An extra 130m of fencing was constructed above gully 1. Extra planting is planned for spring 2008, to further reduce the velocity of water entering the gully.
